MJ-1101 Service Manual Addendum
Supplement to the Troubleshooting Section

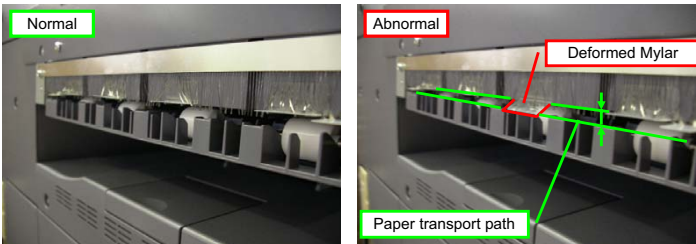
<p>2. Bridge Unit exit Mylar deformed</p>	<p>Check if the Mylar attached to the exit of the Bridge Unit is deformed and obstructing the paper transport path. Correct it if deformed.</p>	<ul style="list-style-type: none"> - Note that the height should be different between the cases when the Finisher is installed in e-STUDIO281c/351c/451c and when installed in e-STUDIO352/452 or e-STUDIO2500c/3500c/3510c.

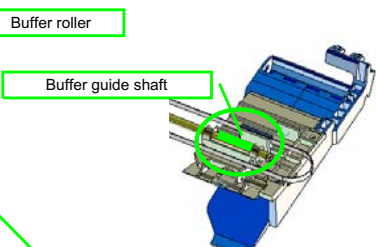
<p>Abnormal</p> </div> </div>	
		<p>4. False operation of the buffer guide</p> <p>(Paper jams may occur if the load is applied to the buffer guide during its opening or closing movement.)</p>	<p>Remove the stationary tray and apply grease "Molykote EM-30L" (the size of 5 grains of rice) to the buffer guide shaft.</p> <div style="display: flex; justify-content: space-around;"> <div style="text-align: center;">

<p>Buffer roller</p> <p>Buffer guide shaft</p> </div> <div style="text-align: center;">

<p>b</p> <p>Molykote EM-30L (the size of 5 grains of rice)</p> </div> </div>	<p>a: Slide the buffer guide to the center and lubricate between the shafts of the front buffer guide.</p> <p>b: Slide the buffer guide forward or backward and lubricate between the shafts of the rear buffer guide.</p> <p>* Be sure to lift up the buffer roller before sliding the guide.</p>

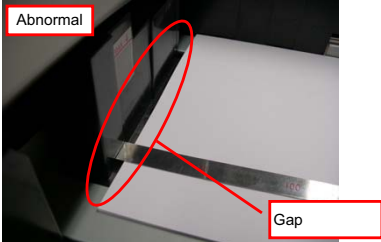
<p>7. Paper not placed properly in the drawer</p> <p>(Paper may be skewed if there is extra gap between the paper and the side wall in the drawer and thus may cause a jam on the Finisher transport path.)</p>

<p>Be sure to lock the side wall.</p>

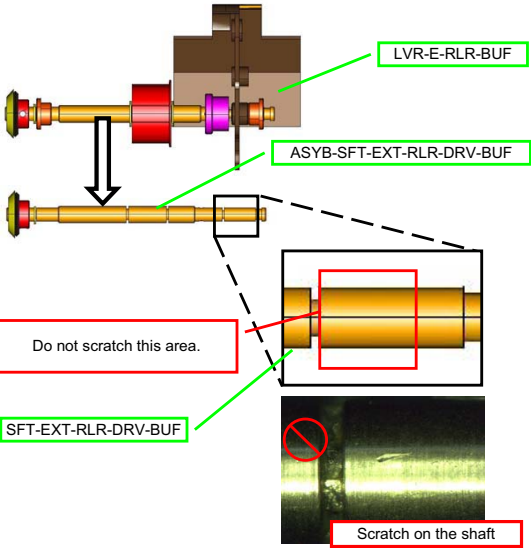
<p>Do not scratch this area.</p>

<p>Scratch on the shaft</p>

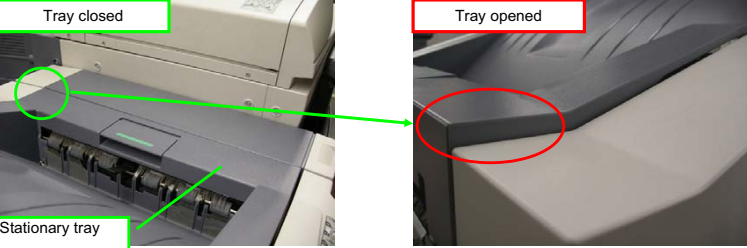
Error code	Phenomenon	Possible cause	Items to confirm / Countermeasures	Precautions / Remarks
EA40	Paper jamming	<p>1. Stationary tray left open</p> <p>(A cover-open error occurs if the stationary tray is left open because the stationary tray opening/closing switch performs false detection during operation.)</p>	<p>Close the stationary tray securely if it is open.</p>

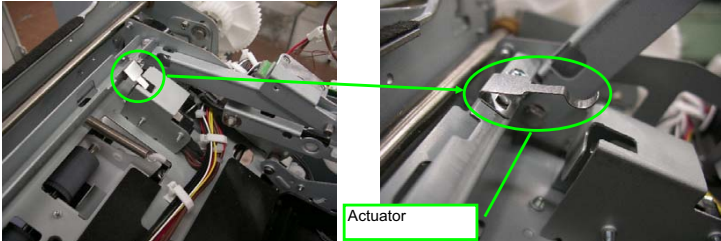
<p>2. Stationary tray opening/closing switch actuator deformed</p> <p>(A cover-open error occurs if the actuator is deformed because the stationary tray opening/closing switch cannot be turned and performs false detection.)</p>	<p>Replace PLT-OPEN-SW-BUF if the actuator is deformed.</p>

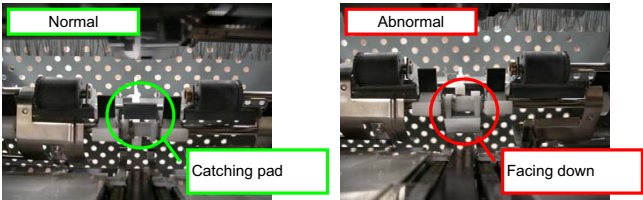
Error code	Phenomenon	Possible cause	Items to confirm / Countermeasures	Precautions / Remarks
EA70 EA60 CC30 CC41	<p>- When more than one sheet of paper is loaded on the buffer tray, the first sheet is pushed out of the tray by the second sheet.</p> <p>- When more than one sheet of paper is loaded on the buffer tray, the leading edge of the second sheet is caught and thus a paper jam occurs.</p> <p>- When paper is transported from the buffer tray to the finishing tray, the paper is run on the front or rear alignment plate.</p> <p>- When paper is loaded on the finishing tray, the front and rear alignment plates excessively push the paper.</p> <p>- When paper is transported from the finishing tray to the movable tray, the paper exit guide catches the paper and thus a motor error occurs because the paper cannot exit.</p>	<p>1. Catching pad deformed or damaged</p> <p>(Paper is not aligned properly due to the deformed or damaged catching pad.)</p>	<p>Check if the catching pad in the Finisher paper exit section is properly attached. Replace it if it is deformed or damaged.</p>

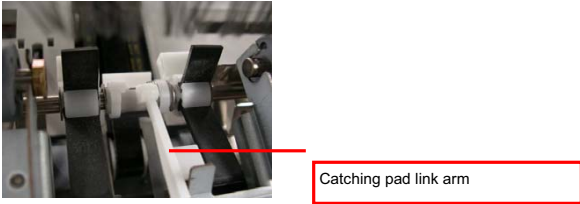
<p>2. Catching pad link arm deformed, damaged or removed</p> <p>(Paper is not aligned properly because the link arm of the catching pad is deformed, damaged or removed.)</p>	<p>Check if the catching pad in the Finisher paper exit section is properly attached. If its link arm is deformed, damaged or removed, replace ARM-SOL-ALIGN (6LB100080).</p>

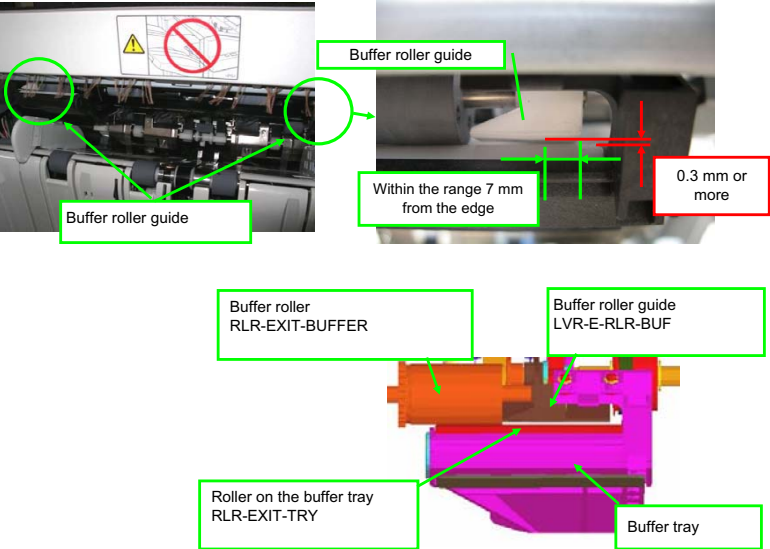
<p>3. Improper roller gap on the buffer roller guide and buffer tray</p>	<p>Turn the power OFF. Then check the gap between rollers on the buffer roller guide and the buffer tray while the buffer roller is left lowered. If the gap does not reach 0.3 mm, replace the buffer roller guides (LVR-E-RLR-BUF) on both front and rear sides.</p>

<p>Check the gap within the range 7 mm from the edge of the buffer roller guide.</p>

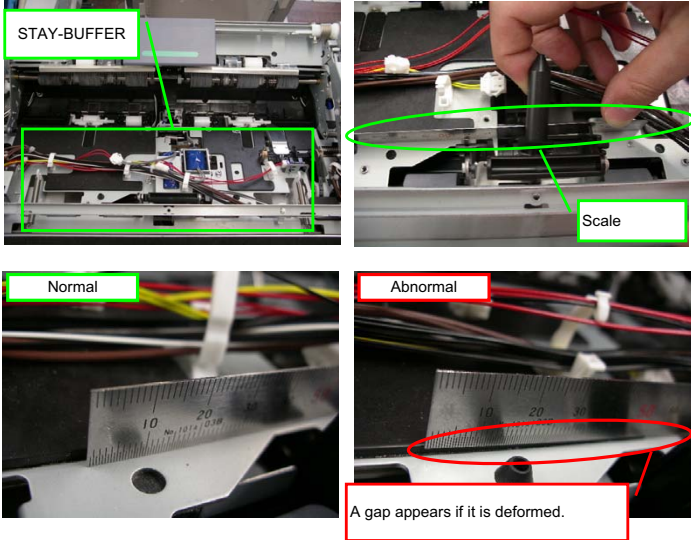
Error code	Phenomenon	Possible cause	Items to confirm / Countermeasures	Precautions / Remarks
EA70 EA60 CC30 CC41	<p>- When more than one sheet of paper is loaded on the buffer tray, the first sheet is pushed out of the tray by the second sheet.</p> <p>- When more than one sheet of paper is loaded on the buffer tray, the leading edge of the second sheet is caught and thus a paper jam occurs.</p> <p>- When paper is transported from the buffer tray to the finishing tray, the paper is run on the front or rear alignment plate.</p> <p>- When paper is loaded on the finishing tray, the front and rear alignment plates excessively push the paper.</p> <p>- When paper is transported from the finishing tray to the movable tray, the paper exit guide catches the paper and thus a motor error occurs because the paper cannot exit.</p>	6. STAY-BUFFER deformed	<p>Remove the bracket of the buffer roller lift solenoid. Then check that STAY-BUFFER is not deformed using a scale or other straight tool. Replace it if it is deformed.</p>

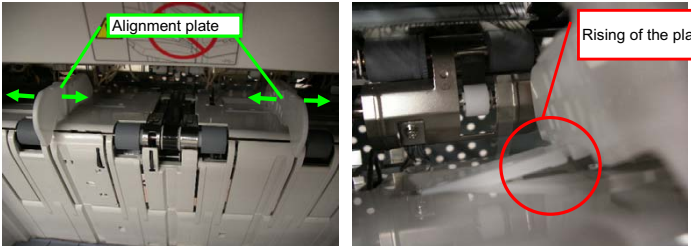
7. Improper installation of alignment plates	<p>If the front or rear alignment plate is removed or its installation is improper, reinstall it. (The alignment plates must not be risen even if they are tilted to the right or left.)</p>

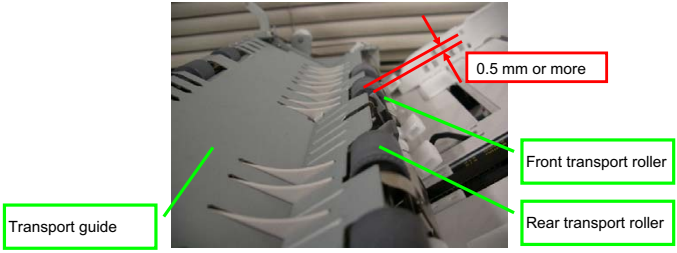
<p>- When paper is transported from the buffer tray to the finishing tray, the paper is run on the front or rear alignment plate.</p> <p>- When paper is loaded on the finishing tray, the front and rear alignment plates excessively push the paper.</p> <p>- When paper is transported from the finishing tray to the movable tray, the paper exit guide catches the paper and thus a motor error occurs because the paper cannot exit.</p>	11. Insufficient ejection of front/rear transport roller	<p>If the front and rear transport rollers are not ejected from the transport guide at 0.5 mm or more, replace the transport guide (GUIDE-FEED-LOW).</p>

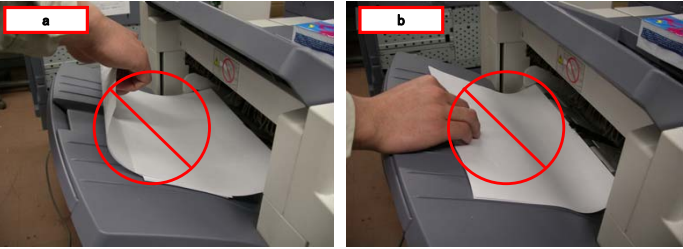
12. Wrong operation by users during printing	<p>An EA70 error may occur if paper exit is disturbed during printing.</p>

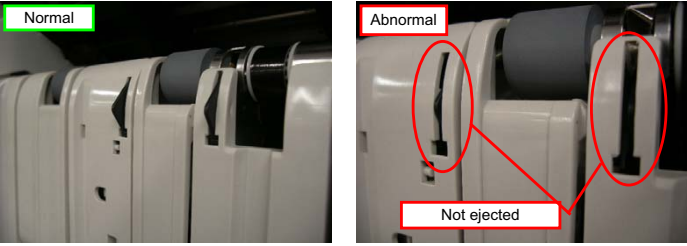
<p>2. False detection caused by the removed actuator spring of the movable tray paper-full sensor (The actuator not ejected)</p>	<p>Reinstall SPG-ACTR-01-TRAY if it is removed.</p>

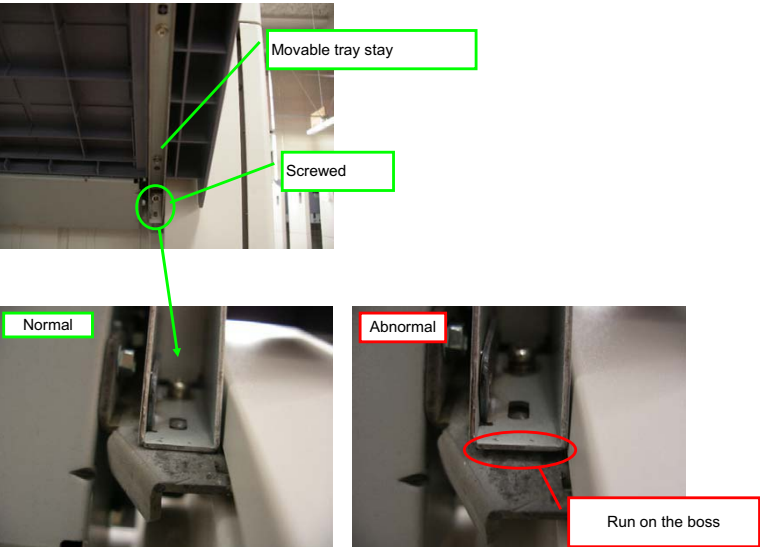
<p>The image shows two side-by-side views of the actuator. The left view is labeled 'Normal' and shows the actuator fully extended. The right view is labeled 'Abnormal' and shows the actuator retracted, with a red circle and the text 'Not ejected' pointing to it.</p>	
		<p>3. Improper installation of the movable tray</p> <p>(An error occurs if the actuator of the movable tray paper-full sensor cannot be pushed due to the improper installation of the movable tray.)</p>	<p>The movable tray may not be installed properly (the stay of the movable tray may run on the boss). Reinstall the movable tray.</p>

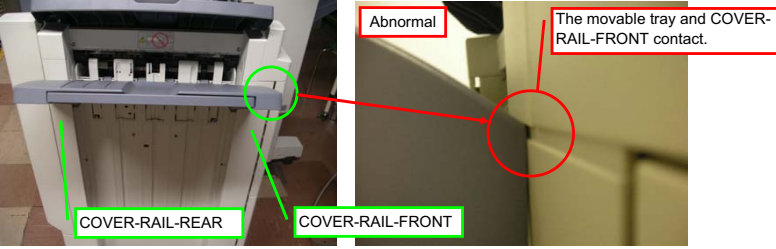
Error code	Phenomenon	Possible cause	Items to confirm / Countermeasures	Precautions / Remarks
CB31	An error occurs because the movable tray cannot be lowered (or lifted up) to the specified position after printing operation.	1. The movable tray cannot be lowered or lifted up because the load is applied to the movable tray by the contact of the tray and COVER-RAIL-FRONT (or COVER-RAIL-REAR).	<p>Check if the inner hooks of COVER-RAIL-FRONT and COVER-RAIL-REAR are properly latched. Reinstall them if not.</p>

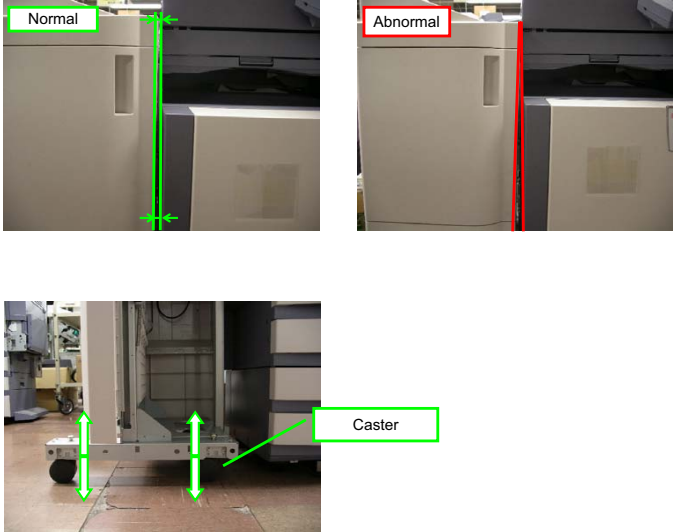
Error code	Phenomenon	Possible cause	Items to confirm / Countermeasures	Precautions / Remarks
CC41 EA20 EA40 EA70	<ul style="list-style-type: none"> - Paper jams at the entrance section of the Finisher (or the Hole Punch Unit) - Folded paper edge - Improper closing of the stationary tray 	3. Tilted Finisher (Paper is not properly transported from the equipment to the Finisher if the Finisher is tilted.)	If the Finisher is tilted as shown below, adjust the height of each caster to make the Finisher horizontal to the equipment.

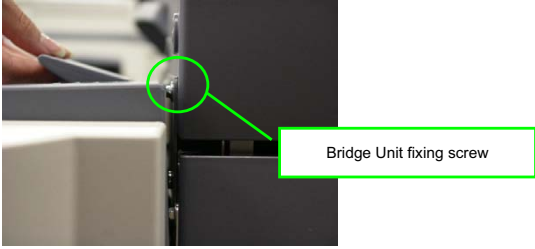
If the Finisher is tilted, the fixing screw of the Bridge Unit and the stationary tray may be contacted when the stationary tray is opened or closed.

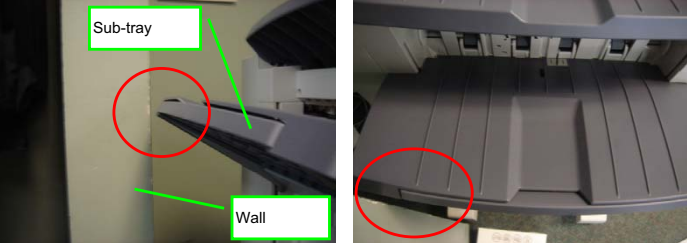
4. Improper exit of large paper	Secure enough space for drawing out the sub-tray when installing the Finisher. If the Finisher is installed as shown in the picture below, the trailing edge of large paper may be jammed when it is exiting.

Be sure to draw out the sub-tray when large paper is used. Otherwise false stacking, paper dropping or an EA70 error may occur.
